NDDH RAAC Risk Assessment

North Devon Hospital

RAAC Visual Assessment Report

100108129-MM-00-SW01-RP-ST-0012

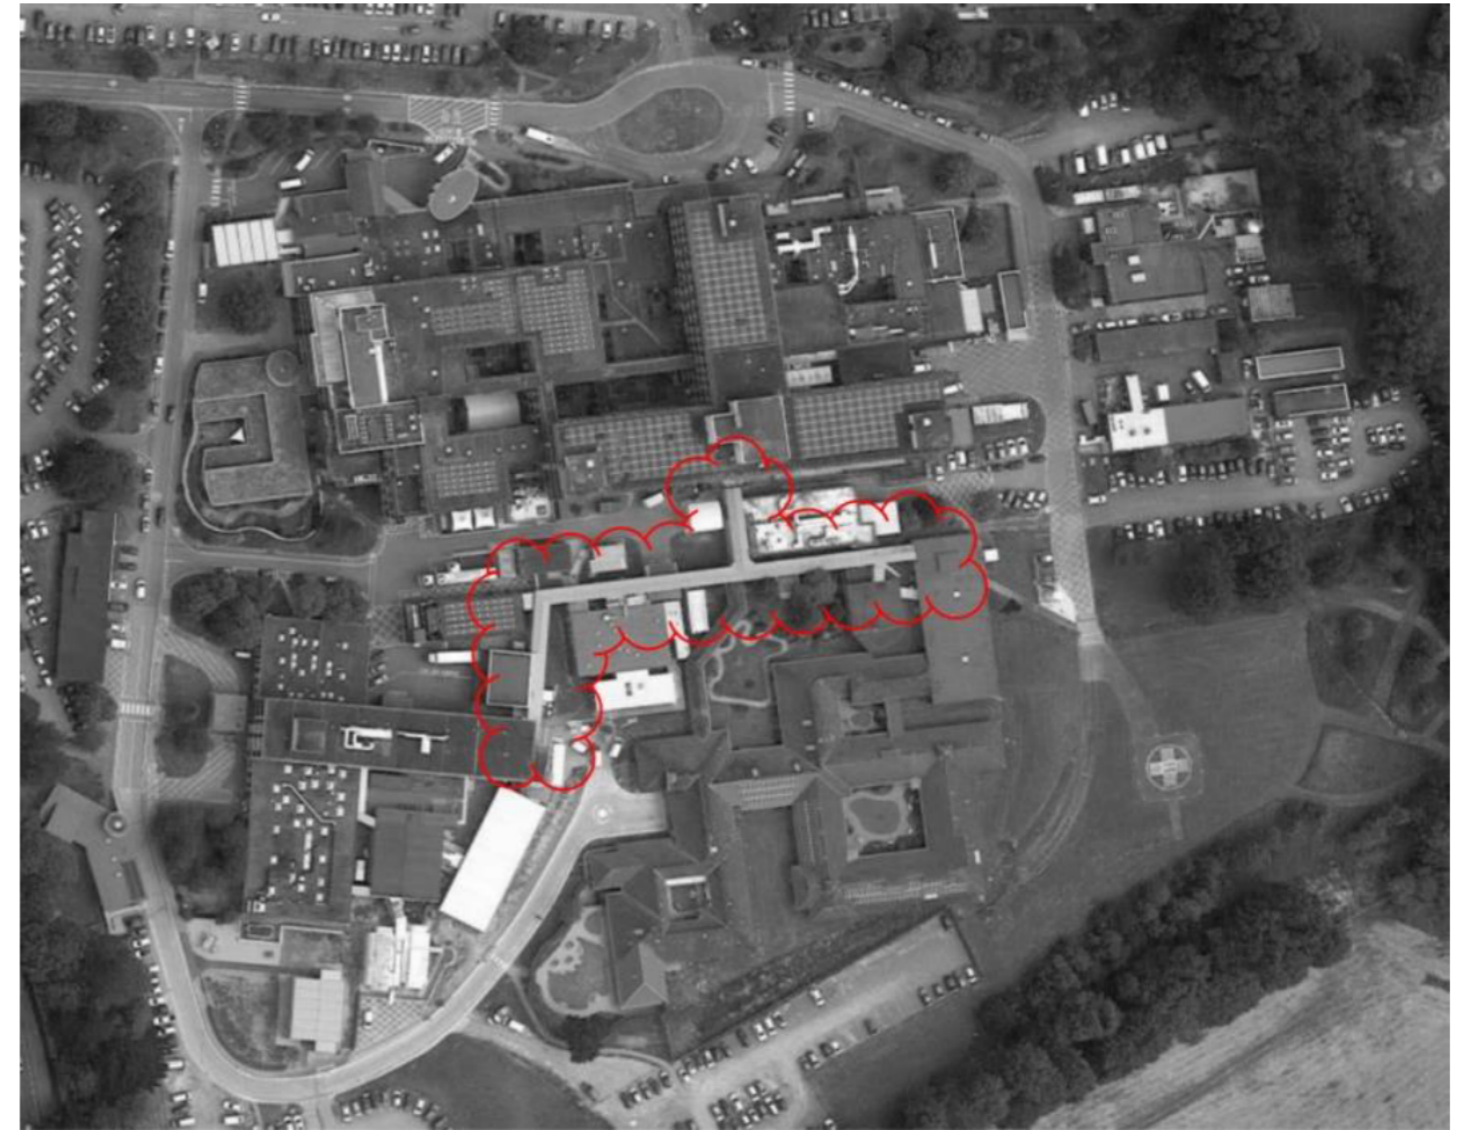
Plan showing summary of site

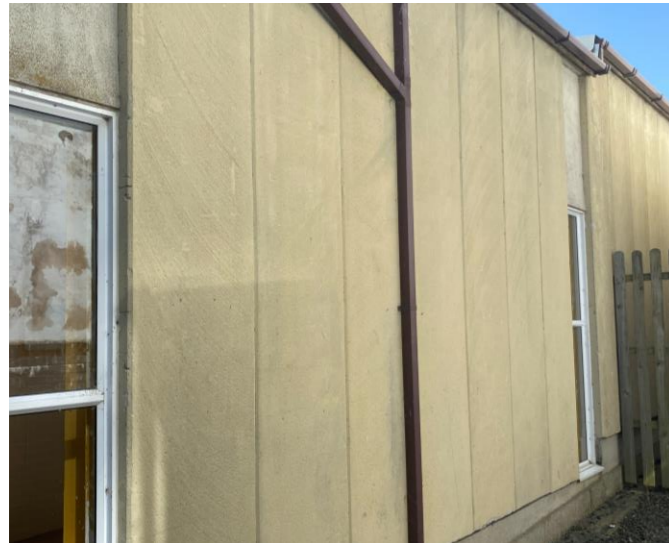
Form of Construction Photo 1
Elevation. Panelised construction

Steel frame supporting metal deck roof and providing restraint to external non load-bearing RAAC wall panels. Wall panels are formed using vertically aligned RAAC panels with a painted finish, stacked off a concrete plinth at the base and supported by the steel frame at the head..

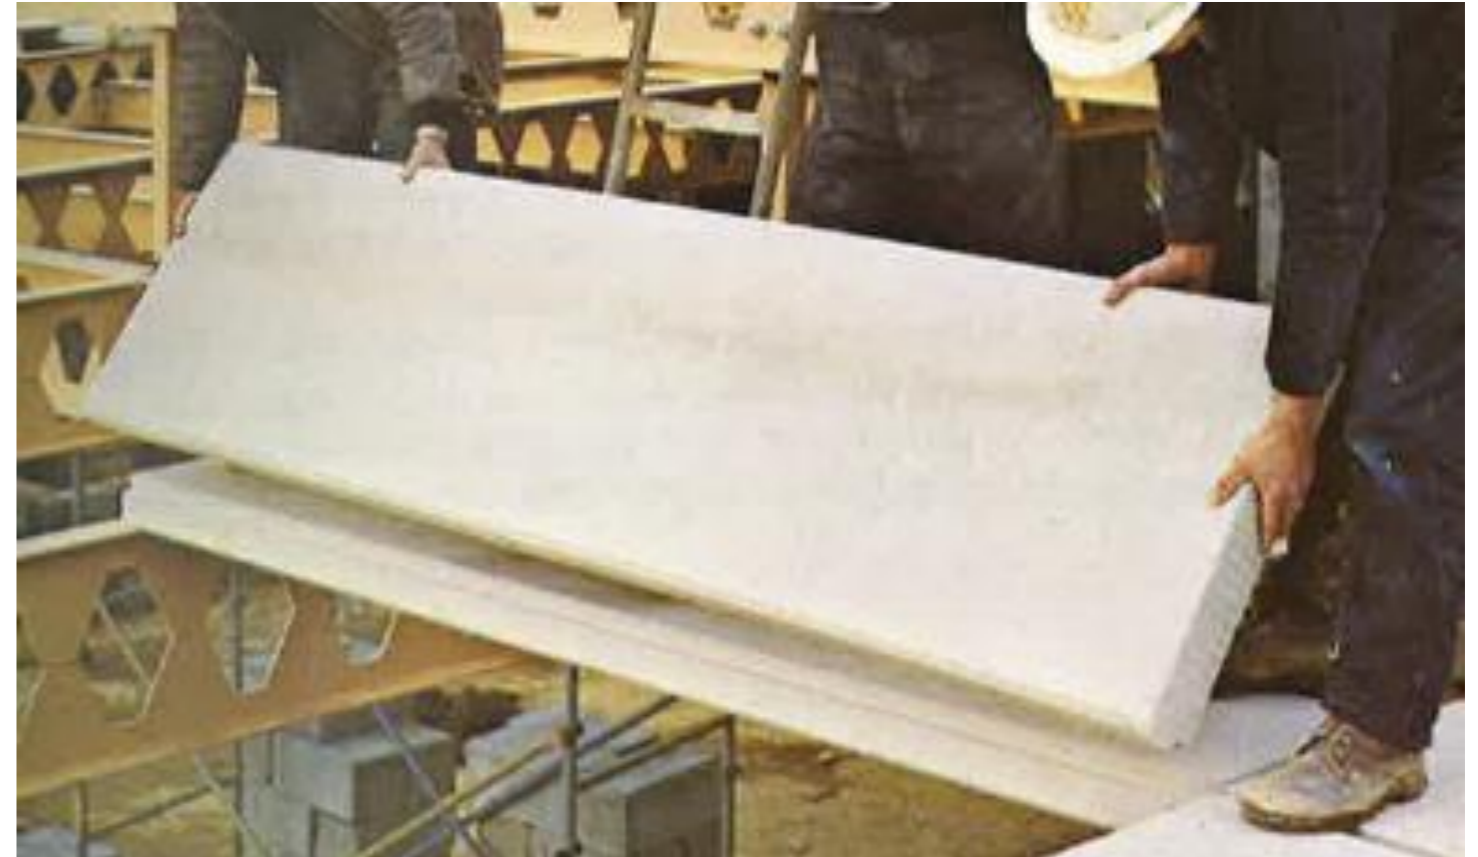
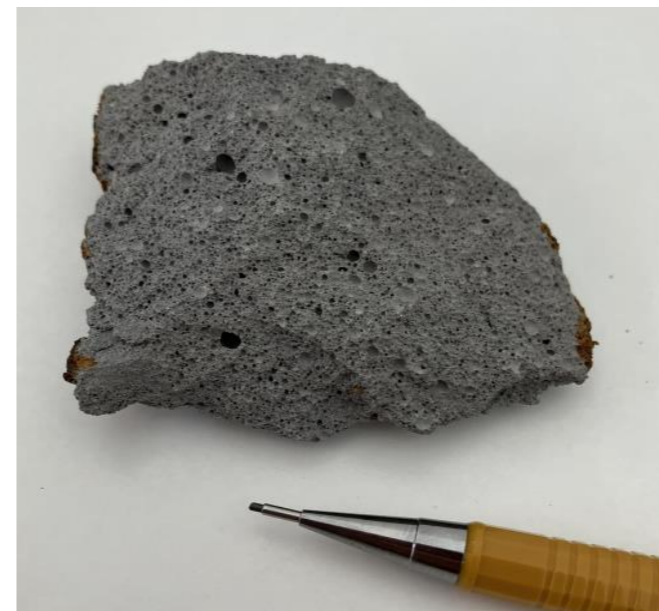
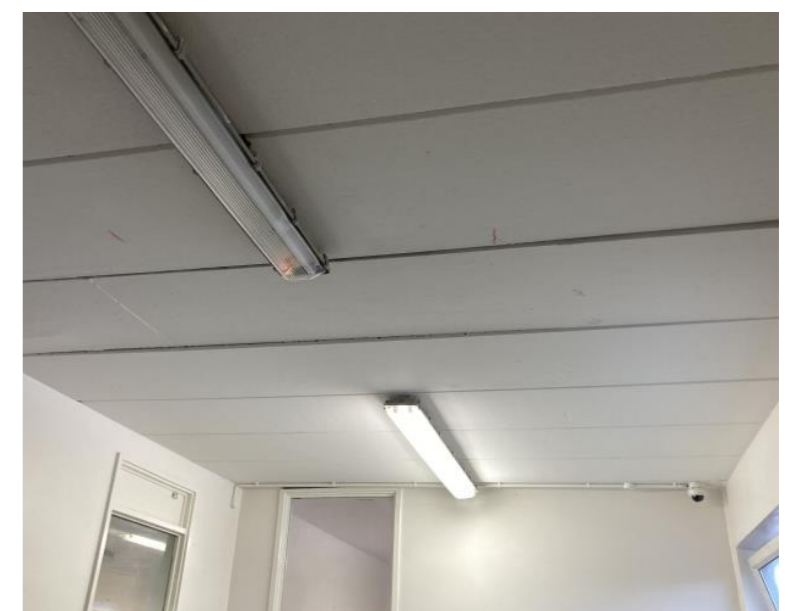
Historic RAAC panel failures have included significant collapses of whole roof structures, occurring suddenly with very little warning. This is typical of shear failures in cementitious materials. An example (extracted from the 2018 SCOSS report) is shown bottom right.
